**STOREFRONT DESIGN:
From Charming to Alarming...and then back again!**

A STUDY IN STOREFRONT REHABILITATION

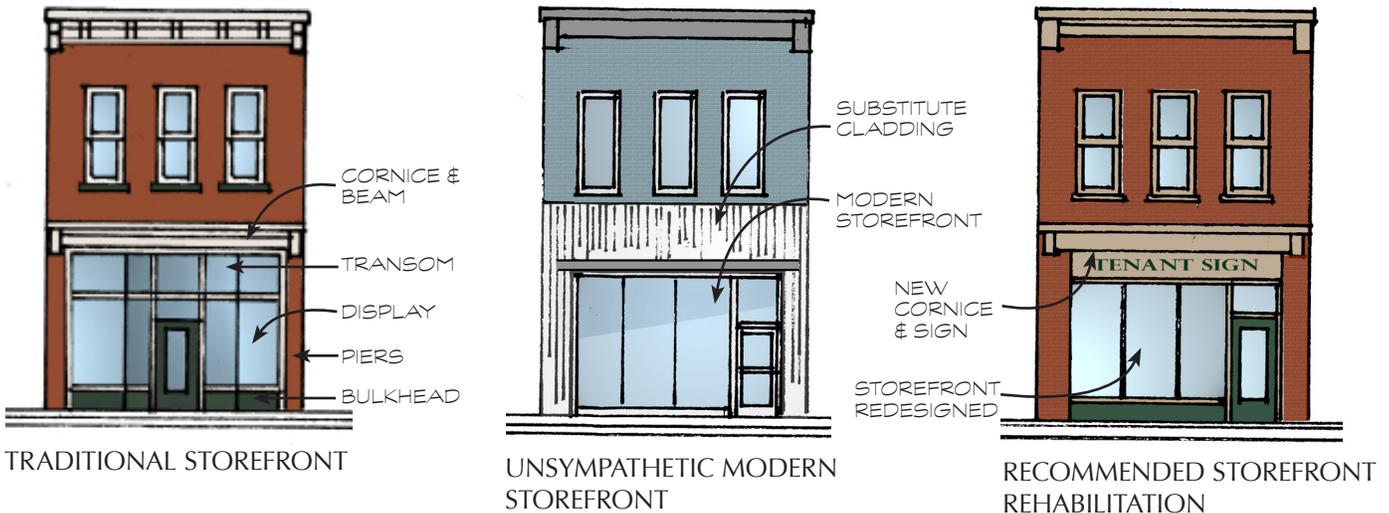
STOREFRONT ELEMENTS & EVOLUTION

In order to answer these questions, a brief history of storefronts is helpful. The structure of most storefronts consists of a void framed by two piers and a beam which supports the upper portion of the building. Sometimes this beam is wood, in most cases it is steel. Decorative elements of early storefronts around the turn of the century were constructed of wood. Wood was easily shaped, turned and carved to create dramatic and finely detailed storefronts. Metal was also used for decorative details, especially at cornices and window hoods. Cast iron may have been used for supporting piers. Beginning around 1915, metal was introduced as framing for display windows. Its thin profile gave glass a continuous appearance, and allowed for larger retail display area. Later, carrara glass panels were used to face storefront piers, bulkheads (the area at the bottom of storefronts) and transom areas. This high quality material was used to create dramatic art deco storefronts in the 1930s as well as to reface bulkheads and piers. Just as important as the materials was the way that

materials were put together to create a harmonious facade appearance: the storefront was set back within the piers and beam; a decorative cornice was part of the design; there were often transom windows; and, in most cases, entrances were recessed.

As modern architecture grew in popularity various components produced for new construction were introduced to the faces of historic commercial buildings. Commonly found features include corrugated metal, enameled steel panels, aluminum display window framing and aluminum framed store doors. Later still, more economical materials were introduced such as vinyl or aluminum siding and vertical wood paneling. In many cases these materials were appropriate for other types of buildings but when introduced to historic commercial buildings they often created a jarring and disjointed appearance on Main Street.

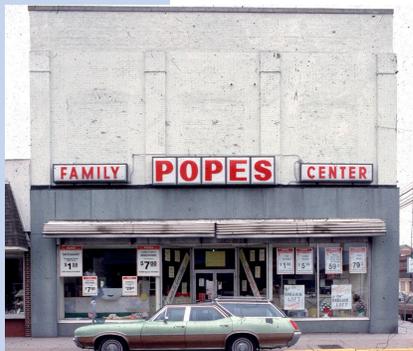
5. If a new storefront is not economically feasible, make some changes to make the existing one a better "fit". Many times when new aluminum framed storefronts were installed, they were not as tall as the original storefront opening. The area between the top of the display and the beam (the old transom area) was framed in and covered up. Create a sign area and cornice that fits this area. This will help a standard modern storefront better fit the proportions of the original building.

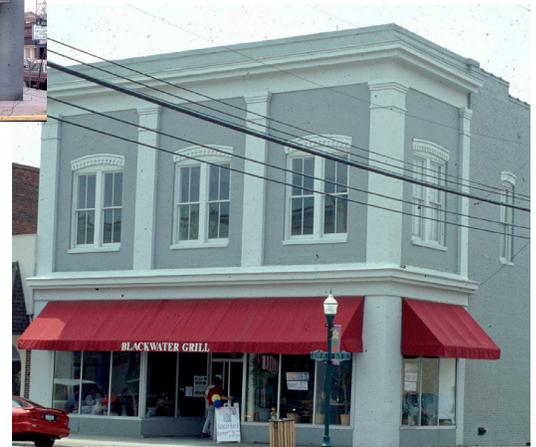
This Franklin building features a sensitive new storefront and enhancement of existing historic elements.

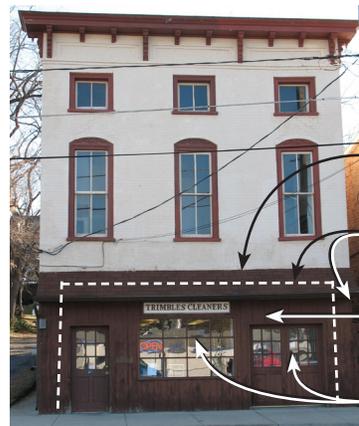
EXISTING STOREFRONT

- MISSING CORNICE
- OBSCURED STOREFRONT OPENING & PIERS
- INCOMPATIBLE SUBSTITUTE WOOD SIDING
- INCOMPATIBLE WINDOWS & DOORS

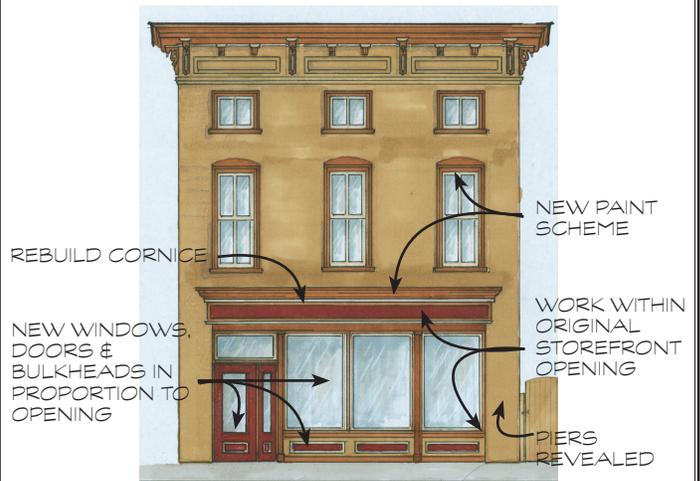
DESIGN FOR NEW STOREFRONT

- REBUILD CORNICE
- NEW WINDOWS, DOORS & BULKHEADS IN PROPORTION TO OPENING
- NEW PAINT SCHEME
- WORK WITHIN ORIGINAL STOREFRONT OPENING
- PIERS REVEALED

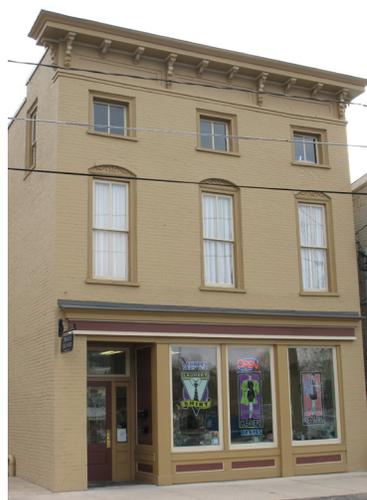
REHABILITATED STOREFRONT

THE RESULT:
Improved Building For Downtown...
Improved Image For The Business Owner...
A SUCCESS STORY FOR MAIN STREET!
